Calendar

**A year of
process safety incident
case studies**

This calendar of process safety incident case studies was prepared by Peter Davern, Department of Chemical Sciences, University of Limerick, Ireland.

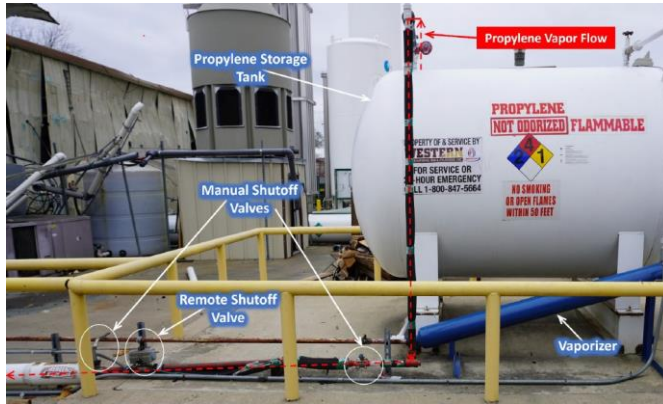
Figure 1: Post-incident photo of the propylene storage tank

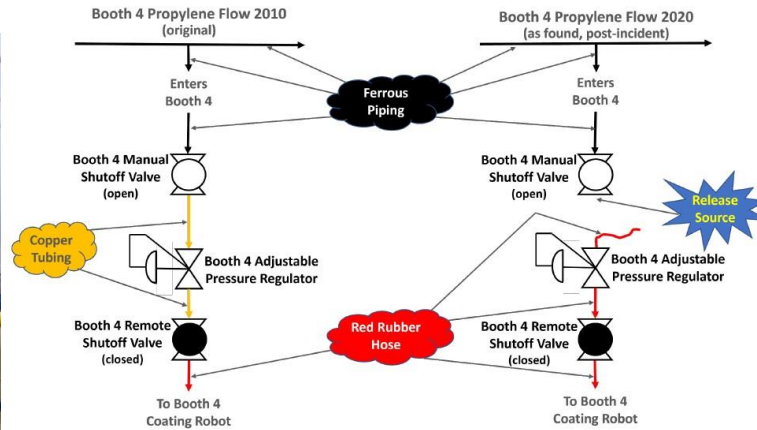
- There was no management of change review of the decision to change the rigid copper tubing on Booth 4's gas equipment to a flexible red rubber hose (Figure 2).

- The red rubber hose was not suitable for propylene service and had therefore degraded. Also, Watson had stopped using factory-crimped hosing in favour of hoses being crimped by the coating booth operators, and the red rubber hose was found to be poorly crimped, post-incident.

Figure 2: Simplified propylene flow diagram of the Booth 4 gas equipment as originally installed in 2010 (left), and as found, post-incident (right)

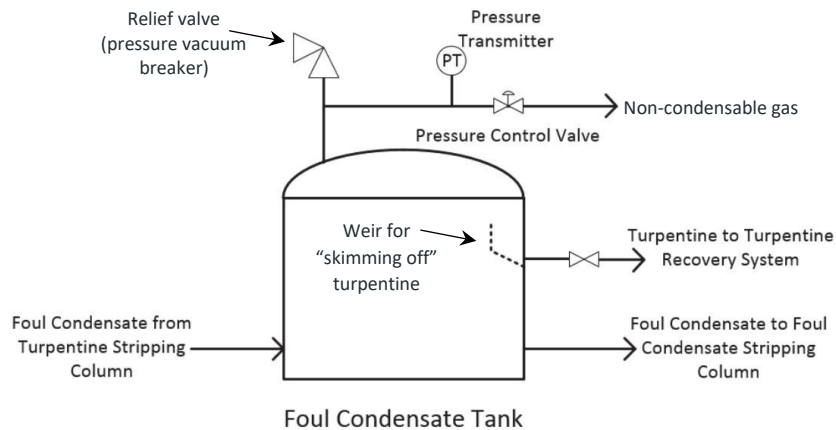
Figure 1: Simplified drawing of the foul condensate tank. The top of the weir (dotted line) sits approximately 6 meters from the base of the tank. As the liquid inside the tank rises above 6 meters, liquid is “skimmed” into the weir and sent to a turpentine recovery system.

- The tank's design did not adequately address the scenario of a flammable atmosphere developing within. It could have been (i) fitted with a low-pressure alarm to alert that the vacuum relief valve may open, allowing air in, (ii) fitted with an oxygen analyser to alert workers and trigger a nitrogen inertion step, or (iii) vacuum-rated to avoid the need for a vacuum relief valve entirely.

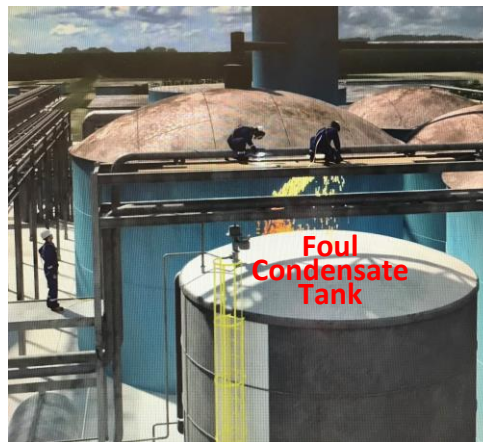
Figure 2: A computer-generated image depicting the hot work being performed on the pipework above the foul condensate tank

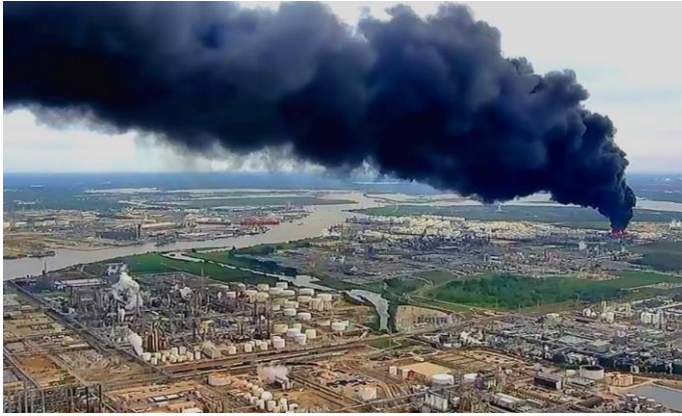
Figure 1: Plume of black smoke rising from ITC's tank farm fire

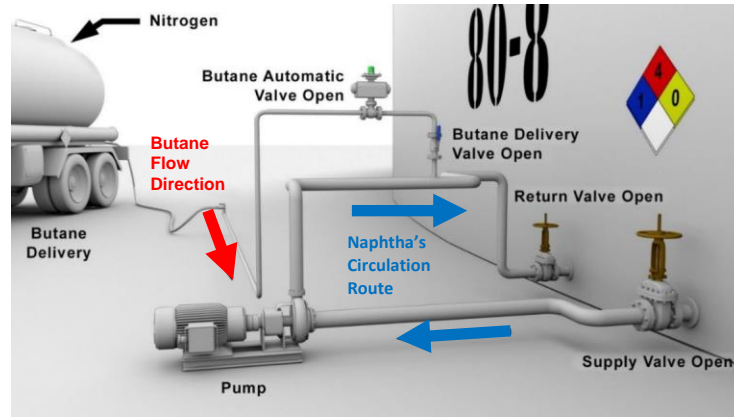
Figure 2: Schematic of ITC's Truck Butane Injection System prior to 2016

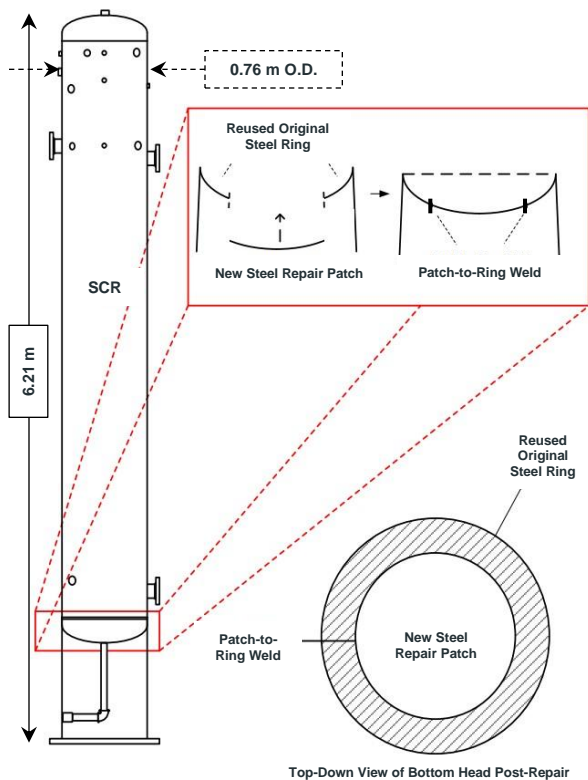
Figure 1: Diagram of repair made to SCR bottom head in 2012

- There was a history of equipment failures at Loy-Lange caused by oxygen corrosion in the steam system.
- The SCR's bottom head repair in 2012 left a corroded steel ring in the vessel that continued to corrode for five years until it failed on the day of the incident.
- The pressure vessel never underwent an annual regulatory inspection because Loy-Lange failed to register it with the relevant local regulatory authority.
- When addressing the risks associated with corrosion in its steam system, Loy-Lange did not employ sound safety management principles like mechanical integrity and incident investigation.

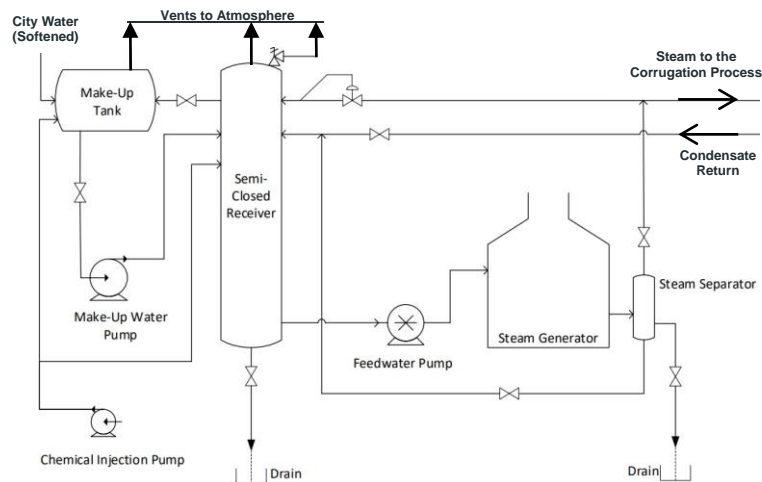
Figure 2: A diagram showing part of the Loy-Lange steam generation system

a steam generation system (Figure 2). The steam generation system used municipal water fed into a make-up tank. There, the water was treated with chemicals and heated to around 93 °C to remove dissolved gases including oxygen, because oxygenated water is corrosive to steel. The water then flowed from the make-up tank into a larger pressure vessel called the semi-closed receiver (SCR). The SCR had a long cylindrical center and two end pieces called heads, all of which were made of steel and thus susceptible to oxygen corrosion. The SCR was kept under pressure to allow the water inside retain more heat than at atmospheric pressure. From the SCR, the water was pumped to a generator that converted it to the steam used to heat the paper. Having heated the paper, the steam condensed back into hot water, which was routed back to the SCR. At the end of the workday, operators shut down the steam generation system leaving the SCR filled with warm water. The next workday, they would restart the steam generation system. During the daily startup, operators would initially block the flow of water into the SCR from both the make-up tank and the condensed steam return line, and the water remaining in the SCR from the day before was pumped to the steam generator. As a result, the SCR's water

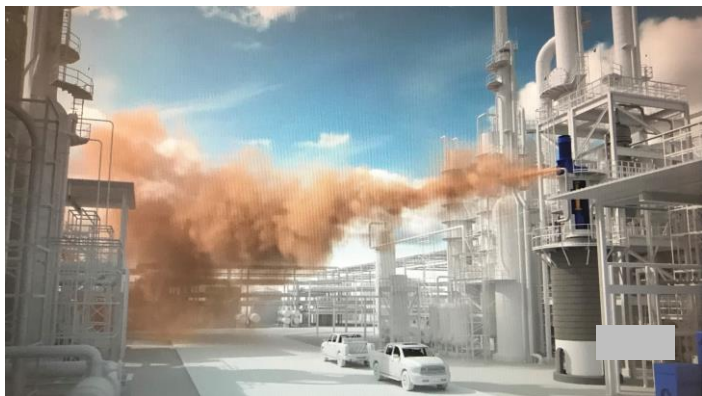
Figure 1: A computer-generated image depicting the horizontal release of ethylene vapour from EVAL Reactor 2's emergency pressure relief system

- Kuraray's long-standing design of its emergency pressure-relief systems deviated from industry standards by discharging flammable ethylene vapour through horizontally-aimed piping into the air, near workers.

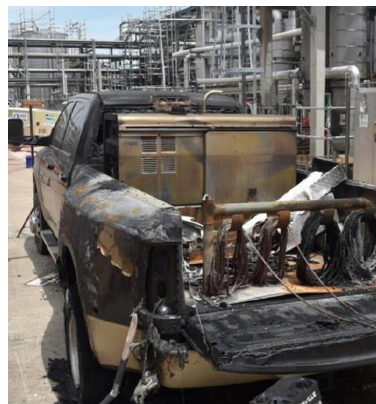
Figure 2: The welding machine on the back of the pickup truck, post-incident

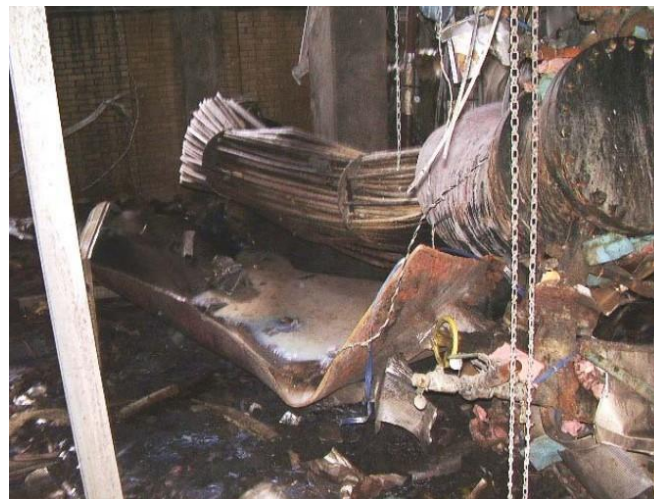
Figure 2: The remains of the ammonia heat exchanger, post-incident

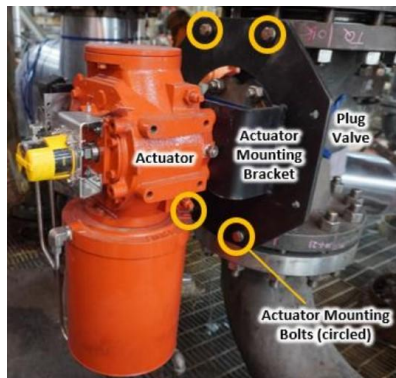
Figure 2: The incident valve with the four actuator mounting bolts circled

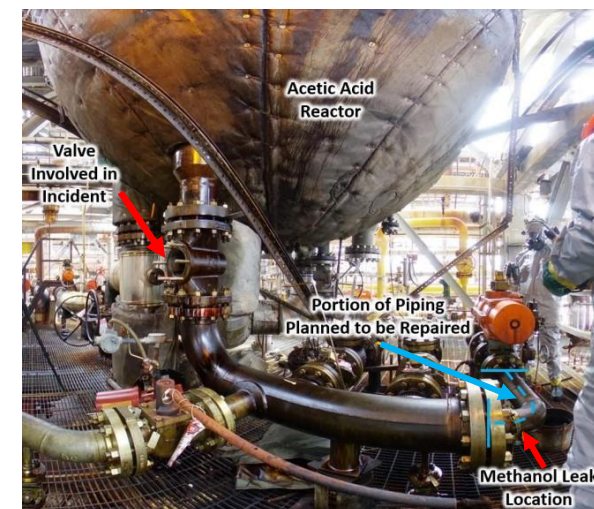
Figure 1: The acetic acid reactor, post-incident, showing the methanol leak location, the portion of the piping for repair, and the location of the plug valve involved in the incident

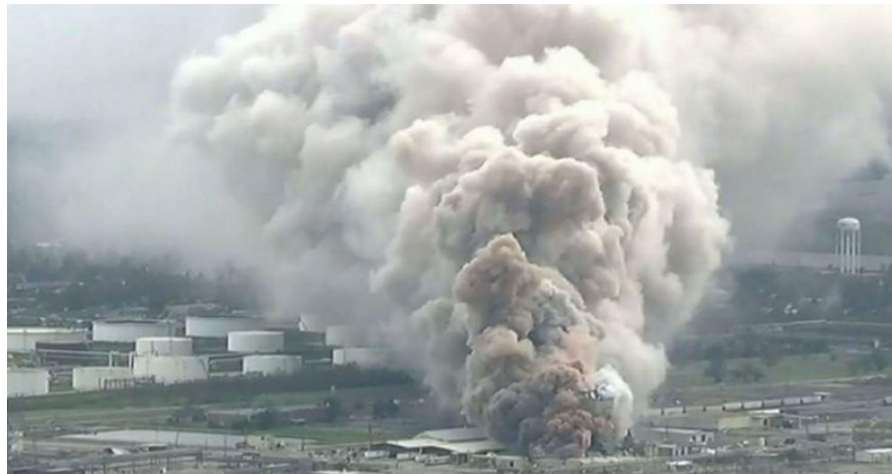
Figure 2: TCCA decomposition gases, including toxic chlorine, released from Bio-Lab Plant 4 after the building was severely damaged during Hurricane Laura and rainwater contacted the stored TCCA

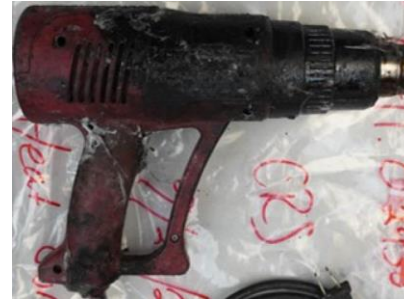
- Blastco's failure to recognise the use of the heat gun as hot work and to inform Evergreen and Rimcor accordingly.
- The cool weather on the night of the incident. Blastco could have delayed lamination work to day shifts when temperatures in the area were 15 – 20 °C.

Figure 2: Electric heat gun recovered from the scene of the incident

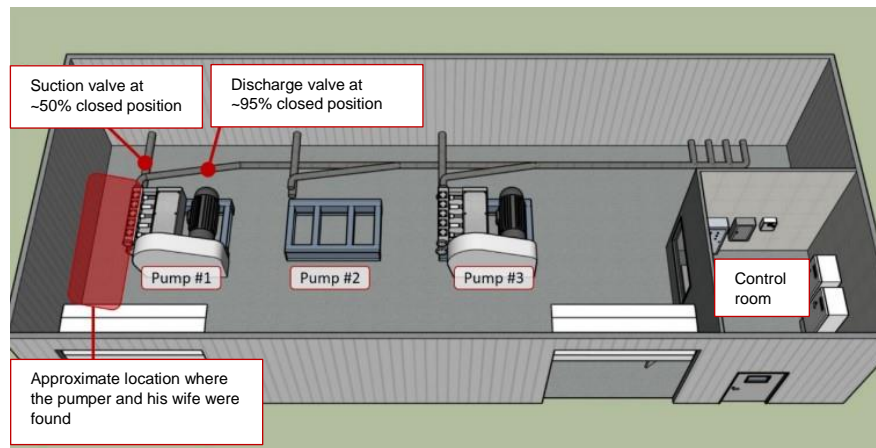
Figure 2: An illustration of the pump house at the waterflood station, showing the control room, Pump #1's suction and discharge valve positions, and the approximate location where the pumper and his wife were found

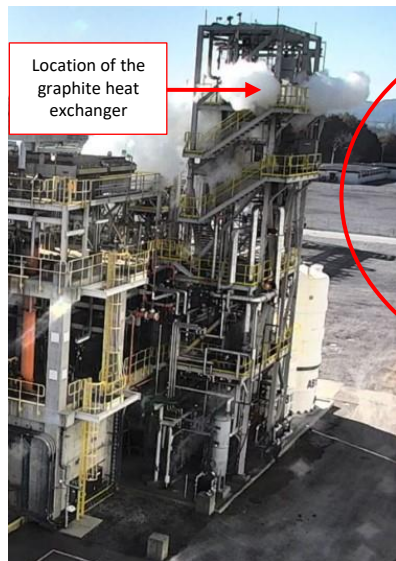
Figure 1: The start of the HCl release

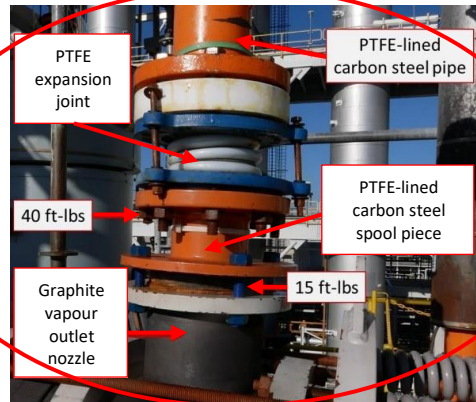
Figure 2: HCl vapour outlet piping on the heat exchanger's graphite vapour outlet nozzle

- The absence of guidance on the torquing requirement for the bolts on the graphite heat exchanger nozzle.
- Wacker did not treat the torquing work on the live HCl-containing heat exchanger as a line break nor as an activity that required isolation of hazardous energy since it did not involve the intentional opening of a line; thus no risk assessment of the work was performed.
- Wacker did not assess the risks associated with two independent parties engaged in simultaneous work tasks (same time and location).
- Three months before the incident, a Process Hazard Analysis (PHA) team recommended installing a ladder with an enclosed cage as a secondary means of emergency escape from the fifth-floor platform, but this was not done by the date of the incident.

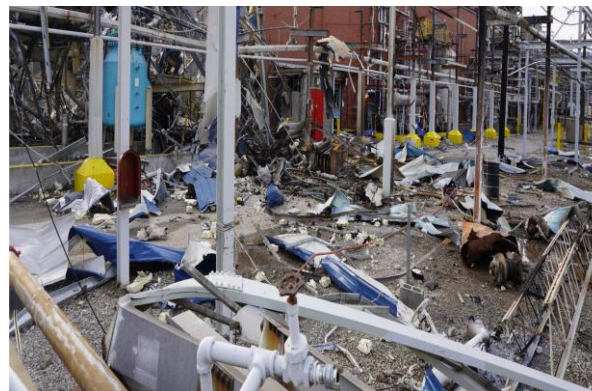
Figure 2: The aftermath of the explosion at Optima Belle LLC
